**DEPARTMENT OF TRANSPORTATION**  
**Federal Aviation Administration**

Effective: 12/12/2018 1200 (UTC)  
Letter to Airmen: LTA-ASE-5

Subject: Wrong Surface Landings

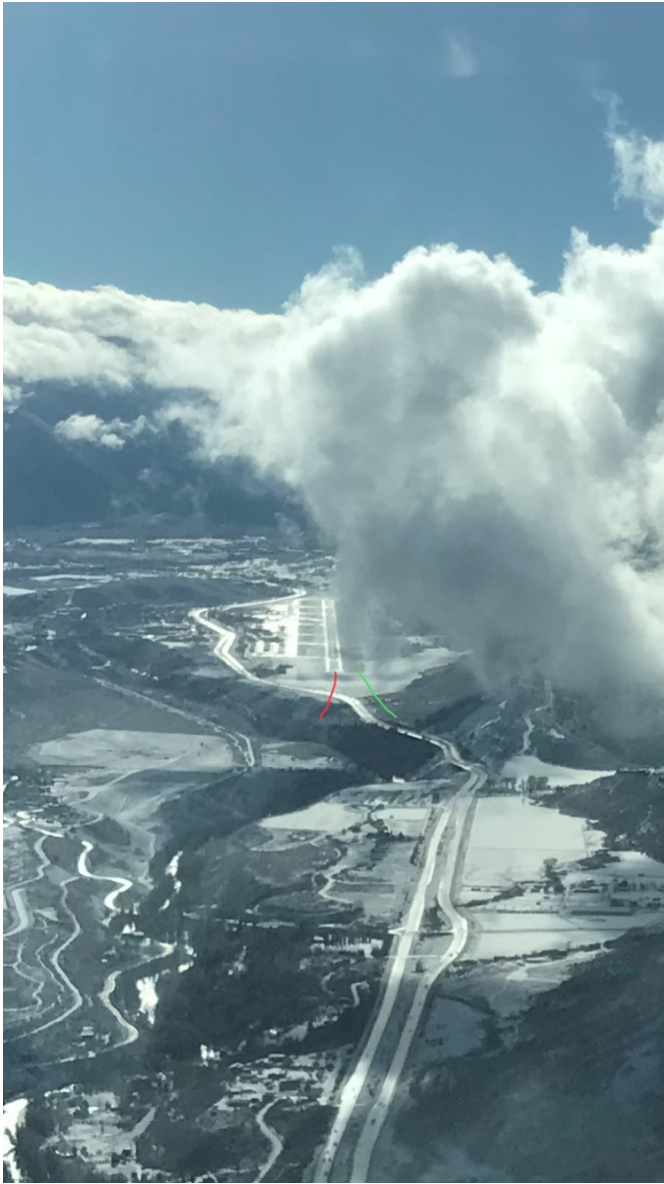
On January 7, 2018, a Falcon Jet landed on the frozen sod west of and adjacent to the runway. Fortunately, there were no injuries and no damage to the aircraft.

Investigation of the incident included conversations with the crew involved as well as other aircrews operating that day. Several individuals reported visual illusions and possible confusion with the landing surface and the area adjacent to it. Further review and discussion revealed an anecdotal history of similar events in the past.

An aircrew, not associated with the referenced incident, took the attached photograph on the same day as the incident. The red line indicates the runway; the green line indicates the sod west of the runway.

A team of stakeholders convened to determine mitigations in order to prevent future occurrences. The team determined that immediate mitigations include this Letter to Airmen and daytime operation of runway lights during winter months.

Aircrews should expect runway lights to be operated on a middle setting during daylight hours. If that is contrary to pilot desires, notify the tower controller and the lights will be adjusted accordingly.
