NBAA REPORT

Business Aviation Compliance With Manufacturer-Required Flight-Control Checks Before Takeoff

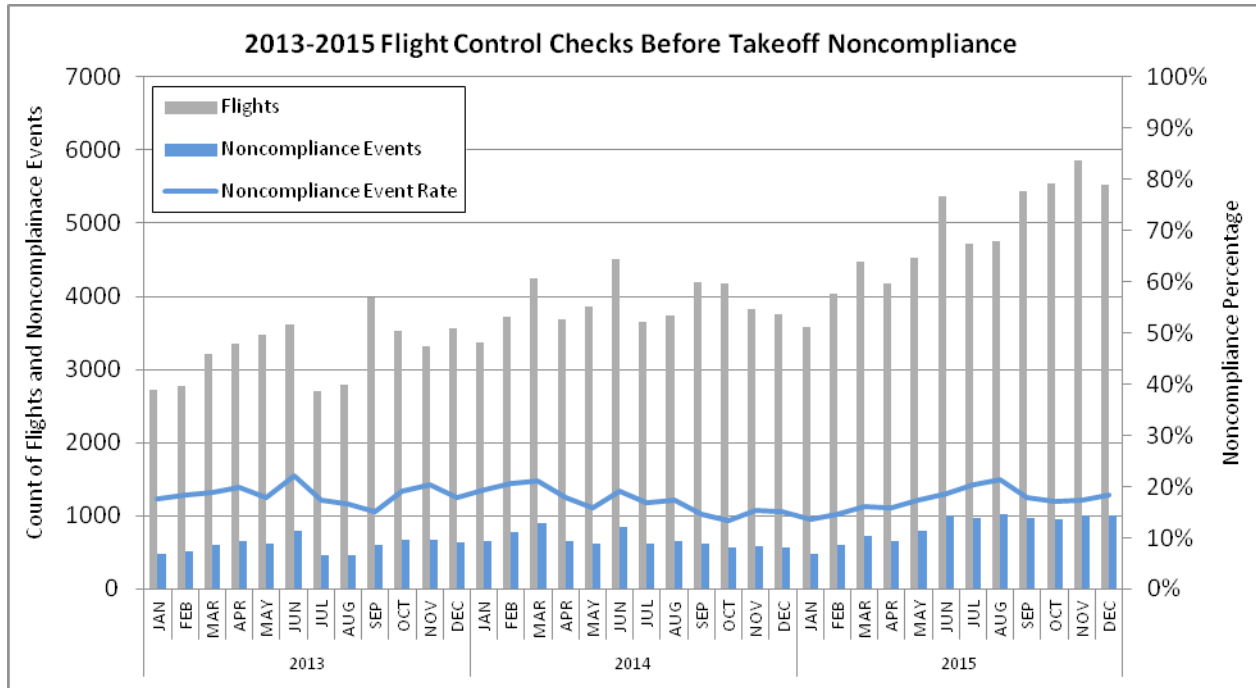
Figure 1 shows the number and percentages of noncompliant flight-control checks before takeoff for each month over the three-year period.

The data shows that out of 143,756 flights conducted during the 2013 to 2015 time period, flight crews conducted a partial flight-control check before takeoff (caution event) during 22,458 flights (15.62 percent). There was no flight-control check before takeoff (warning event) conducted on 2,923 flights (2.03 percent). For the three-year period covering 2013, 2014 and 2015, the overall noncompliance rate for manufacturer-required routine flight-control checks before takeoff was 17.66 percent, reflecting 25,381 events (**Figure 1**).

Caution events averaged 15.62 percent, with a low of 11.36 percent in Jan. 2013 and a high of 19.61 percent in Aug. 2015 (**Figure 2**). Warning events averaged 2.03 percent with a high of 6.29 percent in Jan. 2013 and a low of 0.91 percent in Oct. 2014 (**Figure 2**). The average non-compliance rate was 17.66 percent, with a high of 21.99 in June 2013 and a low of 13.35 percent in Oct. 2014 (**Figure 1**).

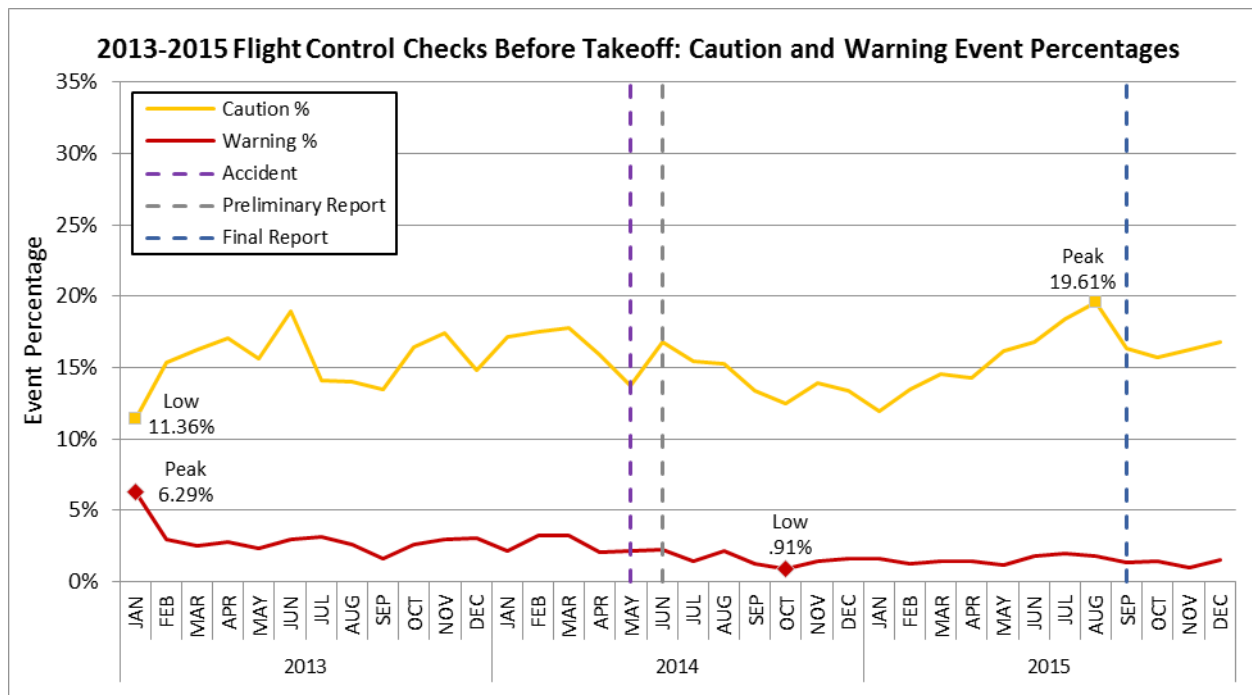
Figure 2 shows the percentages of warning and caution events for each month over the three-year period. It also indicates the accident date, subsequent dates of the preliminary accident report and the final accident report.

The average warning event percentage prior to the accident was 2.80 percent (**Figure 2**). After the accident on May 31, 2014, and the release of the preliminary report on June 13, 2014, the average warning event rate was reduced to 1.47 percent, a drop of 50 percent. That may indicate there was a positive reaction to the preliminary report finding that the Bedford crew did not perform any flight-control check before takeoff. The caution events are more variable, and there is not a significant difference in caution event rates between pre- and post-accident percentages. The noncompliance rate (**Figure 1**) exhibits some minor month-to-month variation, but overall the data indicates minimal effect of the accident report on crew actions in regard to compliance with the manufacturer-required routine normal flight-control checks before takeoff. In fact, the average noncompliance rate from Jan. 2013 to the release of the final accident report in Sept. 2015 was 17.66 percent and the rate from Oct. 2015 to Dec. 2015 was 17.58 percent.
